Esthetic And Functional Rehabilitation Of Mutilated Mandibular Premolar With Fractured Endodontic Post: A Case Report

Abstract

The present case describes the successful removal of the fractured endodontic post and esthetic rehabilitation of a over contoured non esthetic metal crown. Retrieval of the post was done by using ultrasonics, rotary instruments and masserrann extractor kit. Root canal was reinforced by fiber reinforced composite and coronal restoration was done with porcelain fused to metal.

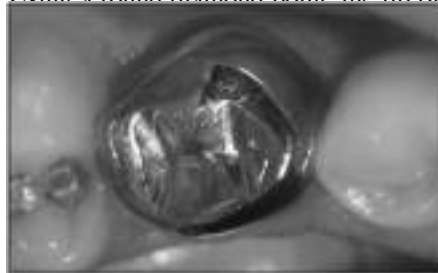
A male patient, 20 years old reported to Department of Conservative Dentistry and Endodontics with the chief complaint of food lodgment and bleeding from gingiva in the right back teeth region. Clinical examination revealed a full metal crown with overhanging margins on mandibular right second premolar (45) and secondary caries in the distal proximal gingival margin of the tooth, under the crown, (Figure 1). Intraoral periapical (IOPA) radiograph of the tooth revealed a fractured endodontic post and the coronal fragment was malaligned compared to the apical part and the root canal obturation was not satisfactory (Figure 2). It was decided to remove the metal crown and excavate the secondary caries, remove the fractured post, reobturate the apical third of the root canal, fabricate a ribbon post and core and finally replace the metal crown with an esthetic crown.

Figure 1. Full metal crown with bulbous gingival margins are seen.

Full metal crown was removed with crown remover. Secondary caries on the distal margin was excavated with round carbide bur in a slow speed hand-piece. Using a round diamond point, the tip of

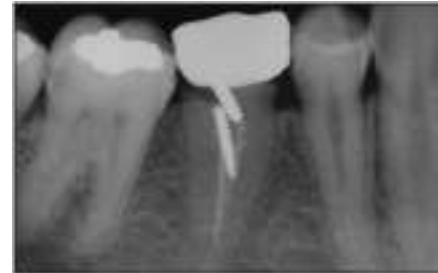
Figure 2. IOPA radiograph reveals over contoured crown and fractured endodontic post.

the coronal fragment was exposed. Then using a tapered fissure diamond point a narrow slot was made around the fractured post and was retrieved by holding with narrow artery forceps. In order to gain access to the apical segment, the canal was widened with number 3 gates glidden drill. With a thin tapered fissure bur, a narrow slot was prepared around the post. Ultrasonic vibrations were used to dislodge the post in counter clockwise direction to the threads. The tip of the post was narrowed by cutting the threads in the most coronal portion to engage the masserrann instrument removal kit. Once it was engaged, rotating in the counter clockwise direction, the fractured segment was removed (Figure 3). The remaining root canal obturation material was removed using H-Files and Endosolv (gutta percha

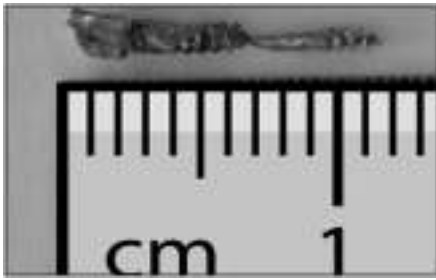
Figure 3. Coronal and apical fractured endodontic post removed.

In the present case ultrasonics and masserann kit was used for the removal of the fractured post as ultrasonics is the easiest, reliable technique with fewer incidences of root fracture and perforations.^[5] The threaded post poses serious difficulties as they are engaged deeply inside the dentine. So masserann instrument removal kit was used to hold the fractured segment and to retrieve it.^{[6],[7]}

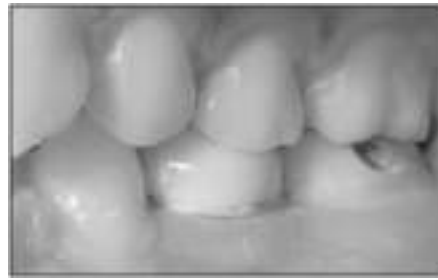
Figure 4. PFM crown cemented and healthy free gingival margin seen.

Clinical examination of the root canal revealed oval shaped canal that was wide and irregular. So it was decided to restore and reinforce the root with ribbon (Poly ethylene fiber) and make a composite core. 3 mm wide ribbon fiber of about 20 mm length was taken and folded. It was moistened in adper single bond 2 (Bonding agent). The canal was etched with 37% phosphoric acid, bonded with adper single bond 2 and flooded with flowable composite. The folded end was placed inside the canal and the free ends were placed coronally. Light curing was done with high intensity LED (light emitting diode) light curing unit (Elipar, 3M ESPE) for 1 minute to ensure complete polymerization of the composite. Core build-up was done with composite resin (Filtez Z-350) and tooth preparation for porcelain fused to metal (PFM) crown was made. PFM crown was fabricated and cemented in the subsequent visit (Fig 4). IOPA radiograph was taken to check the marginal adaptation and contour of the cemented crown (Figure 5).

By replacing with a properly contoured crown, the normal health of the gingiva was maintained. Tooth coloured porcelain fused to metal crown enhanced the esthetic value also.

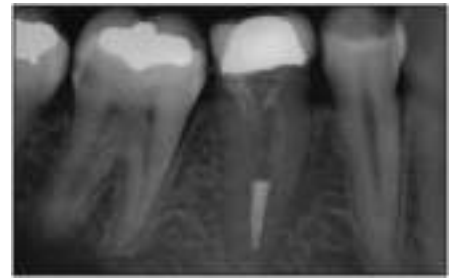
Figure 5. IOPA radiograph reveals proper marginal adaptation and proximal contour. cording Of Neutral Zone Impression
