Evaluation Of Enamel Surface Characteristics Following Debonding Of Ceramic Brackets Using Various Debonding Techniques

Aim: To evaluate the site of bond failure, rate of bracket failure and enamel surface characteristics following debonding of ceramic brackets using different debonding techniques.

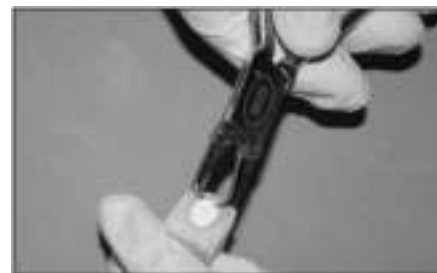
Fig 1: Conventional Debonding.

The first group of 15 teeth was debonded with conventional debonding plier (Skodi Orthodont) (**Figure 1**). The stainless steel blades of the plier were wedged at the bracket adhesive interface

and a gentle squeezing action was applied until bond failure occurred.

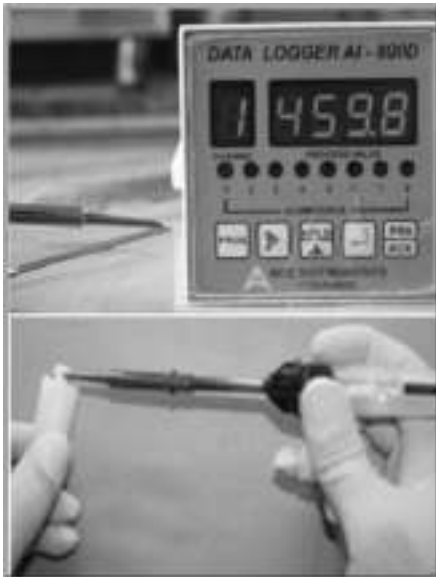
Fig 2: Electrothermal Debonding.

In the second group brackets were debonded by application of heat using customized electrothermal debonding unit (25Watt soldering unit, Poze electronics, New Delhi) which was a

25Watt soldering rod that can produce a temperature of about 400 – 500 °c as measured using the thermocouple (Data Logger AI – 800 D, ACE Instruments, Hyderabad) (Figure 2). The tip of the unit was placed over the bracket for a period of 5 to 6 seconds for heat application and the heat generated was recorded with a digital meter attached to thermocouple. After application of heat for a brief period, the brackets were debonded with the conventional debonding plier.

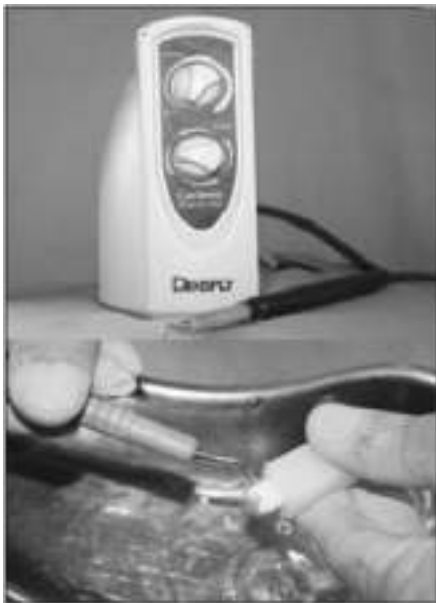
Fig 3: Ultrasonic Debonding.

In this group TFI-1000, 25K Ultrasonic tip and the Cavitron Ultrasonic unit (Dentsply) were used to debond the brackets (Figure 3). The tip was placed at the adhesive bracket interface with the bevel of the scalar tip towards the bracket and was moved in a mesiodistal direction until a groove or "purchase point" approximately 0.5 mm in dimension was created in the composite between the bracket base and the enamel surface. A rocking motion was then applied to break the bond and facilitate bracket removal.

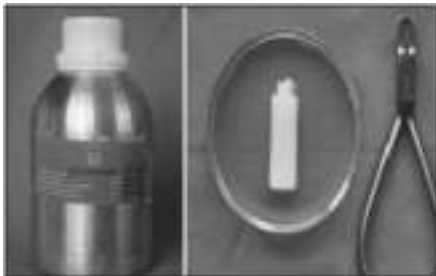
Fig 4: Chemical Debonding.

In the fourth group the teeth were placed in the peppermint oil (L-Menthol: 37-40%, Falcon Essential Oils, Bangalore) for 5min followed by debonding the brackets using conventional plier (Figure 4).
