An Evaluation Of Impact Strength And Fracture Morphology Of Three Denture Base Materials-an In-vitro Comparative Study.

Aim : The aim of this in-vitro comparative study was to evaluate the impact strength and fracture morphology of three denture base materials- Trevalon, Trevalon Hi and Luciton FRS.

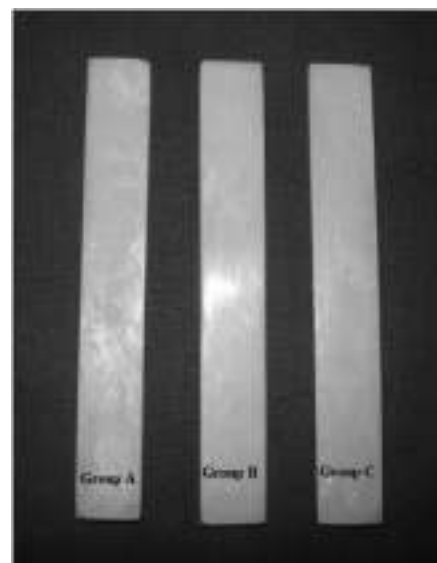
Figure 1: Showing Rectangular Strips Of Three Respective Groups(A,B,C)

Ten rectangular specimens measuring 65mm in length, 10mm in height, and 2.5mm in thickness were prepared for each acrylic resin^{[4],[5]} according to the manufacture's recommendations in

First, the wax was cut with dimension of 65mm in length, 10mm in height, 2.5mm in thickness; dimensions were checked with help of digital vernier caliper. Thirty wax patterns were made and invested with dental stone in metal flask for dewaxing. Denture base acrylic resins of Trevalon and Trevalon-Hi were mixed according to the manufacture's instructions and packed into dewaxed patterns, after dewaxing of wax patterns, when the materials reached the dough stage. These specimens were

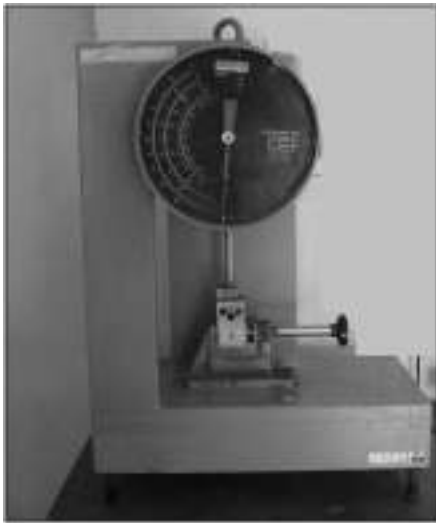
Figure 2: Izod Impact Testing Machine

Testing was done on Izod impact testing machine (CEAST S.p.a., Turin, Italy) (Figure 2) with a pendulum of load 7.5J in air at $31\pm 3^{\circ}\text{C}$. Before testing, pendulum was released to freely swing in the air to record the air resistance (AR) encountered by free-swinging pendulum^{[4],[5]}. Air resistance of 0.7 Joules was recorded. The readings were taken on scale where pointer was stabilized after swing. The specimen was clamped in vertical position precisely and fractured by the pendulum. Pendulum was released and reading indicating energy absorbed (EA) to break the specimens on scale was recorded. All the specimens were tested in the same manner. Impact strength of specimen was calculated by using following formula -

Impact strength = Corrected Readings/ W
Where, Corrected readings = (EA - AR) in Joules

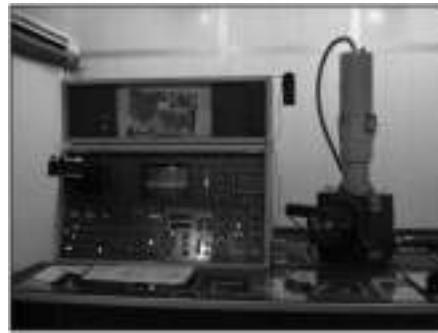
Figure 3: Scanning Electron Microscope

polymerization cycles were subsequently submitted to SEM (LEO, 430, Germany) to verify micro structural behavior and fracture morphology (Figure 3).

For fracture morphology test under SEM, one fragment of the each sample was taken and cut 2mm from the fractured surface with the help of micromotor and carbonadum disk. Then it was coated with gold, so as to increase the density of electrons striking the fractured denture base. All fragments from both

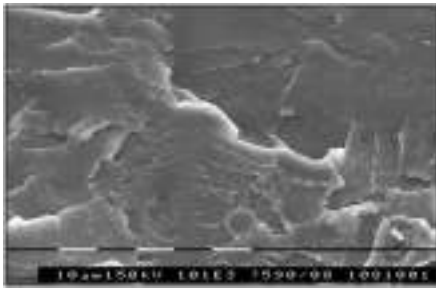
For fracture morphology, SEM microscopy showed that group - A, which is most brittle as compared to other groups, exhibited well - defined, flat, compact and organized surface fracture, it showed some grooves, but depth of

Figure 4: Sem Fracture Morphology Of Group A

grooves was least amongst the three groups (**Figure 4**)

In this study, the fracture morphology of denture base material which had lowest impact strength that was group-A exhibited well defined, flat, compact and organized fractured surface and the fracture morphology of denture base material which had impact strength more than group-A that was group-B exhibited disorganized and jagged and irregular surface when compared with group-A. Group-C that showed highest impact strength exhibited completely disorganized, more irregular and jagged surface than group-A and group-B. Similar fracture morphology was seen by Fernanda Faot et al, the denture base resins which had more impact strength values exhibited more number of intermediate fractures and those denture base resins which had low impact strength values, exhibited more number of brittle fractures.

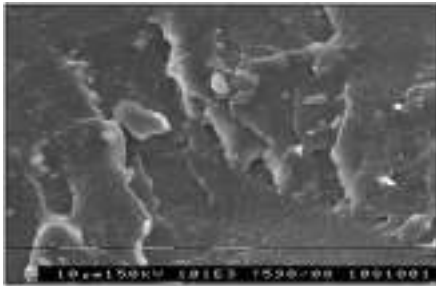
Figure 5: Sem Fracture Morphology Of Group B

Group-B, which lesser brittle material than group-A, exhibited disorganized and jagged and irregular surfaces, when compared to the group-A with, high number of grooves are present. Crazing was present in group-B. The grooves were also present and the depth of grooves were higher than group-A (**Figure 5**).

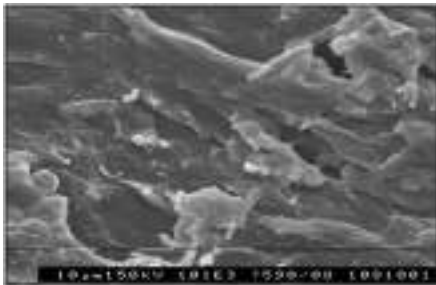
Figure 6: Sem Fracture Morphology Of Group C

Group-C, which showed highest impact strength, exhibited completely disorganized and the most irregular and jagged surface amongst the three groups. It showed highest number of grooves, which are deepest among the three groups. The highest crazing was present in group-C (**Figure 6**)

1. The mean impact strength of Luciton FRS(Group C) was significantly higher than both Trevalon-Hi(Group B) as well as trevalon (Group A).
2. Trevalon-Hi showed significantly higher mean impact strength as compared to Trevalon.
3. SEM microscopy showed that Trevalon is most brittle and exhibited well defined, flat, compact and organised surface fracture.
4. Trevalon-Hi is less brittle than Trevalon, exhibited disorganised and jagged, irregular surfaces.
5. Luciton FRS exhibited completely disorganized and the most irregular and jagged surface amongst the three groups.
