## Aesthetic Management Of Fractured Endodontically Treated Tooth - Case Report

### Case Report

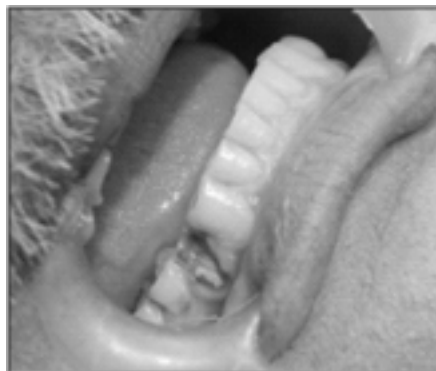
Figure 1 : Crown fracture of 44

Crown fracture was seen with 44 (Fig1). IOPA were taken in relation to 44 (Fig2). On radiographic examination the obturation was found to be intact and as the tooth was asymptomatic.

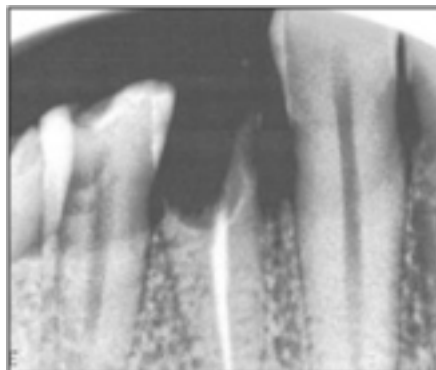
Figure 2 : IOPA of 44

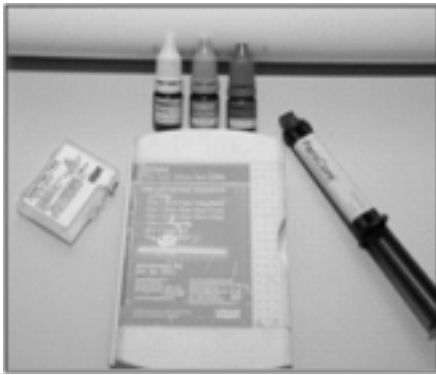
Figure 3 : Fibre esthetic post system

On the basis of clinical and radiographic findings following treatment plan was made, restoration of the tooth with pre fabricated post, core build up and a porcelain jacket crown. For Post space preparation 4mm of guttapercha was removed from the pulp chamber using a thin straight fissure bur. Post space was prepared with size no.2 piezo reamer supplied by manufacturer. FRC post of sizes number 2 (TANEX- fibre trans esthetic post system, Coltene Whaledent, Fig 3) with its diameter 1.06 was selected. The prepared space was cleaned with normal saline, air dried and para bond non rinse conditioner (Fig 3) was applied with help of an applicator tip for

20 seconds. After that two drops of each para bond adhesive A and adhesive B (**fig 3**) were mixed in dispenser with help of applicator tip. It was uniformly applied in the prepared post space. It was then light cured for 20 seconds. Dual cure flowable composite resin cement (Para Core) was inserted into the post space after which the fibre post was inserted (**Fig 4**). The fibre post and composite were cured together for 60 seconds. The excess coronal portion of the fibre post was cut with the help of a diamond bur. Final finishing and polishing was done with finishing burs and crown preparation for porcelain jacket crown was done (**Fig 5**). The crown was finally cemented with tooth using GIC luting cement (**Fig 6**).

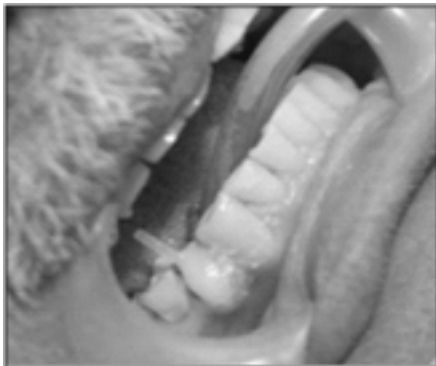
Figure 4 : Fibre post and composite were cured

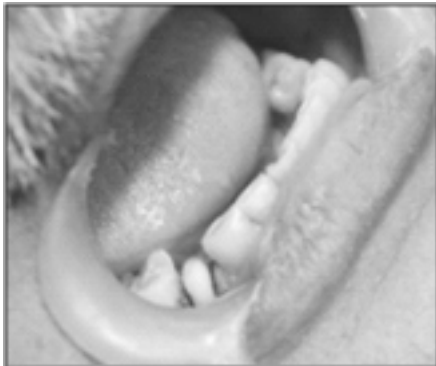
Figure 5 : Crown preparation of 44

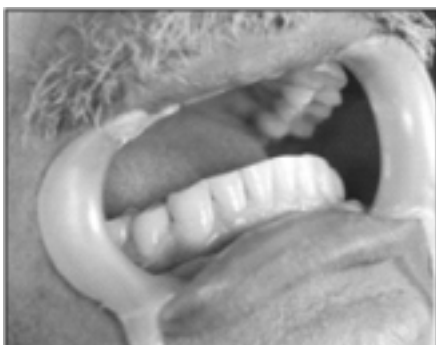
Figure 6 : Porcelain jacket crown cemented.
