Reterival Of A Endodontic Fractured Instrument: Challenges And Perception

An unpleasant and frustrating complication during root canal treatment is instrument fracture within the root canal. The present case reports describe the successful removal of a fractured endodontic instrument in the root canal. Various techniques and treatment modalities are available for instrument retrieval from root canal and most of them have brought about unpredictable results causing a lot of damage to the remaining root. Removal of a separated instrument from a root canal must be performed with minimum damage to the tooth and the surrounding tissues. Therefore, an alternative technique utilizing cyanoacrylate adhesive was utilized with success. This method is quick, efficient and practically possible to remove the separated instruments from the canal.

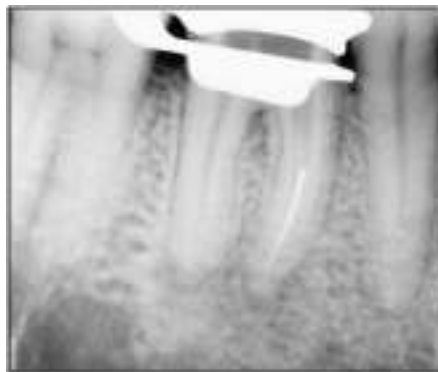
Figure 1

Local anaesthesia was administered (Xylocaine 2% adrenaline). Isolation was done using rubber dam (Hygenic, Coltene/Whaledent Inc). Access opening was done using endo-access bur. Initial exploration of the canal was done using K file #10. K file #15 was the next instrument used in the canal. K file #15 instrument fracture was observed in the distobuccal canal of the tooth. A radiograph was taken to confirm the instrument separation. In the radiograph, the instrument was seen extending from the apical third to the coronal orifice of the canal (**Figure 1**).

Gates glidden drill was also used for the enlarging root canal. Appropriately sized ULTRASONIC instrument was selected, such that the length will reached to the broken obstruction and its diameter will passively fit into the previously shaped canal. Then the ultrasonic instrument was placed in intimate contact against the obstruction and typically then it was activated within the lower power setting. Ultrasonic action trephines, sands away the dentin and exposes the coronal few

millimeters of the obstruction begins to loosen, unwind and then spin. And it was revealed that the instrument could be partially bypassed and that it was loose within the root canal.

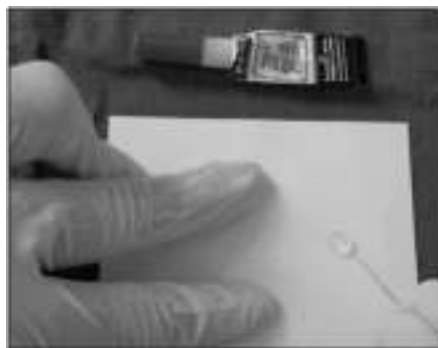
Figure 2

After Drying The Canal with 20 no k file was taken and the cyanoacrylate adhesive was applied onto the file (**Figure2**), then taken into the canal that will adhere firmly with the broken instrument (**Figure3**), and after not moving the combination slowly in coronal direction Will Bring The Broken Instrument Safely Out Of The Canal. (**Figure 4, 5**). When instrument removal was completed and before obturation, a radiograph was taken to confirm whether the instrument was absent as in successful cases or in the case of failure, the size and location of the remaining fragment. Success was defined as complete removal of the fractured instrument from the root canal without creating a perforation (**Figure 6**). The canal was then routinely prepared and all canals filled with lateral compaction of gutta-percha and AH26 (Dentsply) sealer (**Fig. 7**).
