Coronaradicular Rehabilitation Of A Widened Root Canal Treated Tooth: A Case Report

This article presents a case report in which excessively widened canal was narrowed using light transmitting plastic post and successful restoration of function and esthetics was achieved by using glass fiber post and composite core and final PFM crown in a patient of broken front tooth.

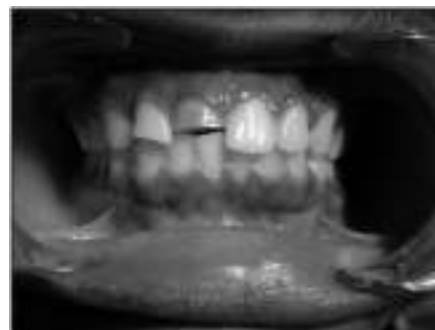
Figure 1

A patient aged 18 years, reported to the department of prosthodontics with the chief complaint of upper front tooth broken and discoloured. History of his present complaint revealed the trauma to left maxillary incisors due to fall from the bicycle 11/2 years back. Clinical evaluation revealed Ellis class III fracture in 11 and Class II fracture in 12 (**Figure 1**). Root canal therapy was done in 11 few months after the trauma and the tooth was asymptomatic. The canal was inordinately wide due to iatrogenic dentistry that he underwent somewhere else, however apical seal was satisfactory.

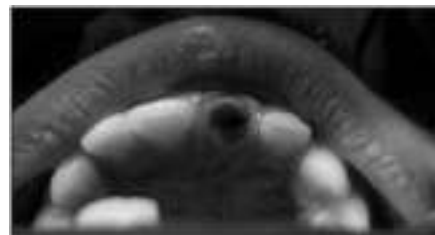
Figure 2

The canal was very much widened near the access cavity (**Figure 2**). The diameter of the canal was calculated to be 4.3mm mesio-distally and 2.1mm bucco-palatally, which was much more than the recommended post diameter of 1.7mm in central incisor.

It was planned to narrow the canal with flowable composite using light transmitting plastic post to the desired diameter and then finally restoring the

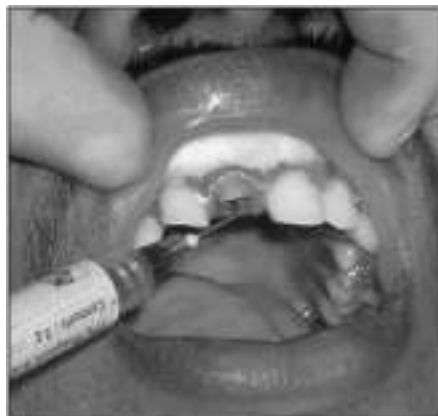
Figure 3

Light transmitting plastic post (Dentatus, USA) of diameter 1.7mm was chosen to narrow the widened canal. The post space walls were etched with 37% Phosphoric acid gel that was introduced into the canal with the needle (**Figure 3**) and after 30 seconds it was rinsed with distilled water and thoroughly dried with chip blower and paper points until no visible blue color and moisture could be observed. A bonding agent was applied gently into the canal using super fine micro brush, excess was removed using paper points, the adhesive was gently air dried for 5 seconds and light cured for 30 seconds. The canal was filled with flowable composite and light transmitting plastic post was introduced into the canal (**Figure 4**). It was light cured for 60 seconds through the cervical portion of the root and after that the plastic post was removed. The canal diameter was again measured and calculated to be 1.7mm.

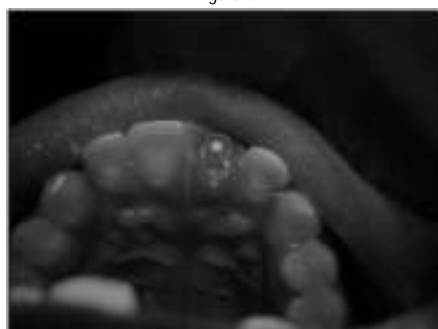
Figure 5

The glass fiber post of diameter 1.7mm was selected and tried into the canal and marked 10mm according to the post space (**Figure 5**). The excess was sectioned with water cooled diamond rotary cutting instrument (R879.014; Diaswiss, Geneva, Switzerland) at high speed to avoid separation of glass fibers from its resin matrix. The IOPA X-ray was taken to confirm the snugly fit of the post. The canal was again washed with distilled water and dried with paper points. The acid etching was done again for 30 seconds and thoroughly washed and dried. The post was also etched for the purpose of cleaning, then rinsed and dried according to manufacturer's instructions. The bonding agent was applied into the canal and onto the glass fiber post and cured for 20 seconds. The dual cure resin cement was mixed according to manufacturer's instructions and applied into the canal using Lentulo

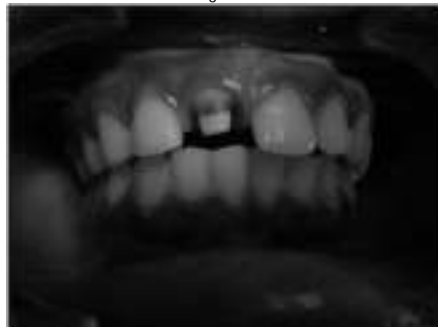
Figure 6

spiral and also over the post surface. The glass fiber post was introduced into the canal to the full depth and kept under finger pressure for 1 minute. Then it was light cured for 60 seconds with the tip of the light curing unit in direct contact with the coronal end of the post. The core build-up was done with composite in increments which were light cured for 20 seconds each time and shaped with slow speed burs using a micromotor (**Figure 6**).

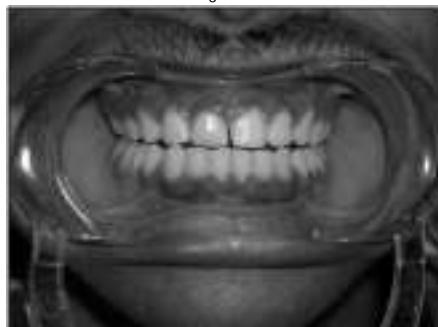
Figure 7

The temporary crown was cemented with non-eugenol cement. After two weeks, the completed PFM crown was luted with GIC cement. The broken incisal edge of 12 was build up with composite of appropriate shade (**Figure 7**). The patient was happy and satisfied with the final work.
