Management Of Fracture Prone In Maxillary Complete Denture - A Clinical Report

Clinical Report

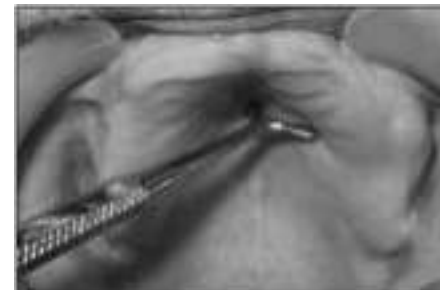
Classification) labial frenum, class I (According to House Classification) buccal frenae, V-shaped hard palate and prominent midpalatine raphe. Palpation of midpalatine raphe area and alveolar ridge revealed that there is marked difference in mucosal resiliency and mucosa is loosely attached at midpalatal area (Fig-1).

Fig.1 : V - Shaped Palate & Prominent Midpalatine Raphe.

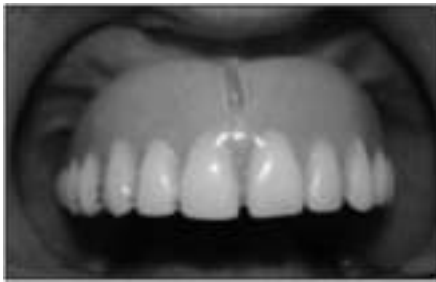
On examination of maxillary prosthesis it reveals the labial notch was too broad but encroached to labial frenum, maxillary teeth were arranged too buccally and anterior interferences were also present (Fig-2). The thickness of acrylic denture base was approximately 3mm in palatal area. The fracture line was extending from labial notch to the post dam area throughout the midline (Fig-3).

Fig 2 : Over-trimmed Labial Notch.

In this clinical report, repeated fracture of maxillary complete denture occurred due to low and broad (class III) labial frenum, labial notch in maxillary denture was over trimmed, too buccally arranged teeth.

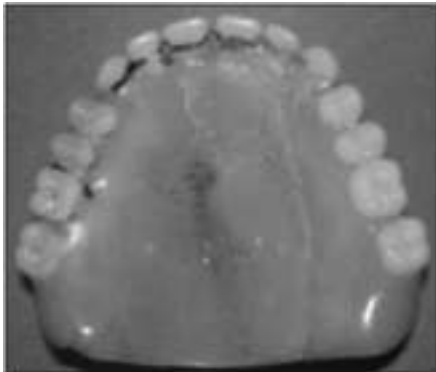
Fig.3 : Fracture Line Of Maxillary Complete Denture.

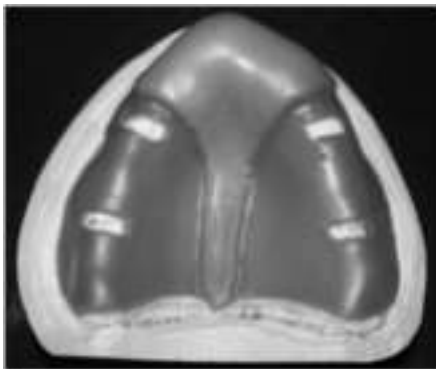
Fig.4 : Modified Spacer Design.

resiliency. To compensate this, modification was done in spacer design by increasing the thickness of spacer twice in midpalatine raphe area, by providing umbrella spacer along with full arch spacer (Fig - 4). This provides more thickness of impression material to record the midpalatine area in relieved state. The final impression (wash impression) was made with zinc oxide eugenol impression paste (DPI Impression paste, Mumbai) (Fig -5).

Palatal relief in the anterior portion of palate is planned to reduce excess load over median palatine suture. Modification in spacer design was done by increasing the thickness of spacer wax twice in midpalatine area, by providing umbrella spacer along with full arch spacer to provide extra relief in this area. This provides more thickness of impression material to record the

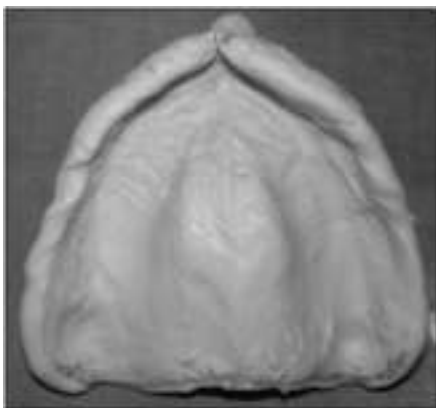
Fig.5 : Final Maxillary Impression.

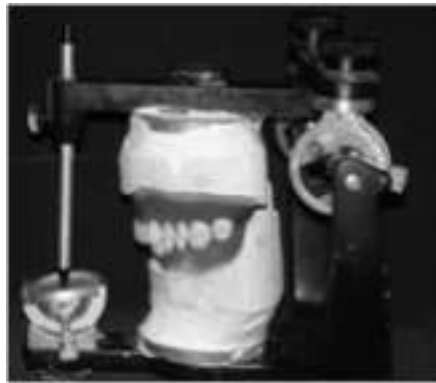
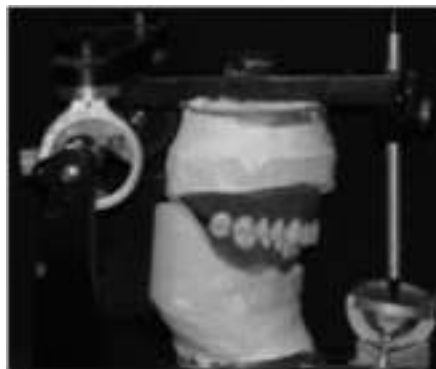
Fig.6 (A) : Teeth Arrangement In Bilateral Balance Occlusion

Fig.6 (B) : Teeth Arrangement In Bilateral Balance Occlusion

After orientation jaw relation record, vertical and centric jaw relation record were made. The neutral zone was recorded at the time of maxillo-mandibular relationship recording by swallowing technique. Teeth were arranged in neutral zone with bilateral balance occlusal scheme to reduce the

lateral forces on residual ridge and torsional forces on acrylic denture base (Fig -6 a, b).

Teeth arrangement was done in neutral zone according to bilateral balance occlusal scheme to distribute the occlusal forces uniformly.

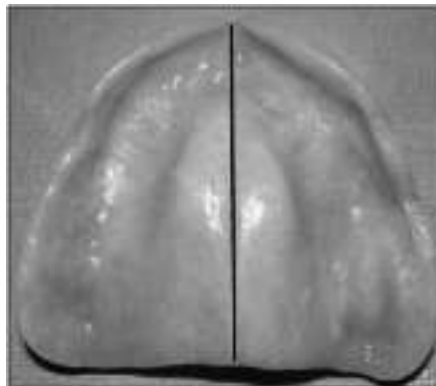
Fig. 7 : Extra Relief In Midpalatine Area.

After denture try in, denture was processed with high impact acrylic denture base material (Luciton 99, Dentsply Canada Ltd.). During denture insertion the maxillary denture was relieved in midpalatine area (Fig - 7). Special care was taken during adjustment of labial notch, that is labial frenum was relieved properly neither it impinge to frenum during function nor over trimmed.
