## Effects Of Tooth Preparation And Poorly Designed Artificial Crowns On Health Of Periodontium And Esthetics : A Case Report

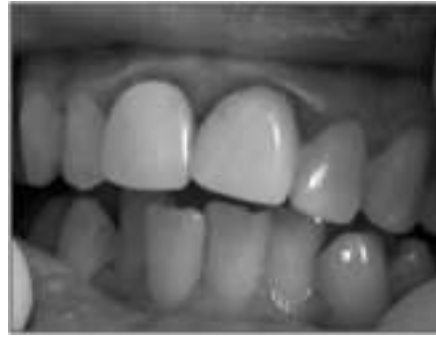
A 22 year old female patient reported to the department of Prosthodontics with the chief complaint of poor esthetics and bleeding from gums particularly during tooth brushing. On clinical examination, it was found that the two maxillary central incisors restored with porcelain fused to metal crowns had poor shade matching and improper alignment. (Fig 1). The free gingival margin was also found to be inflamed related to these two teeth (Fig 1, 2). On removal of the two crowns, it was found that gums were severely inflamed with continuous bleeding. (Fig 2) and both central incisors were inadequately prepared (Fig 3). The crowns were almost resting on gums instead of finish lines.

Fig 1 : Poorly Designed Pfm Crowns

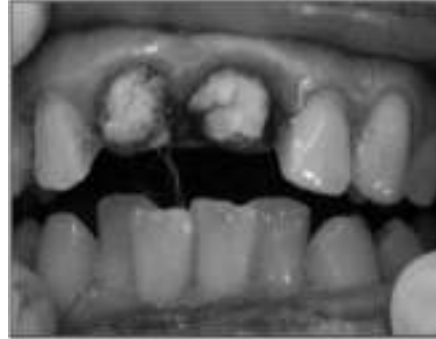
Fig 2 : Gingivitis With Bleeding Gums

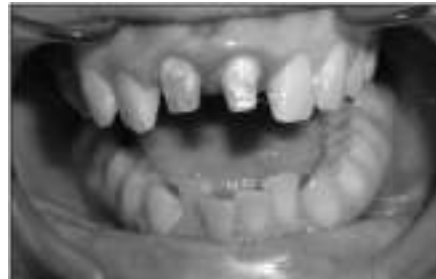
Fig 4 : Labial View - Optimal Prepared Teeth With Subgingival Finis Lines And Self Cure Acrylic Resin Pattern For Cast Post And Core In 11.

It is very important that periodontium should be completely healthy before starting tooth preparation for any type of crown or fixed partial denture. If subgingival finish line preparation is done with inflamed gums, the finish line tends to become equigingival or Supragingival once the gums become healthy. This affects esthetics, particularly if the teeth are in esthetic zone. In this particular case, after the removal of crowns we wait for few days before starting teeth preparation to allow the gums to become healthy (Fig 3). Once the gums returned to normal health, we did tooth preparation with tapered flat end diamond bur to provide shoulder type of finish line. This finish line is prepared perpendicular to long axis of tooth and is about 1mm wide. It is indicated for all ceramic and PFM crowns (labial/buccal side upto contact area where ceramic is applied over the metal coping) because ceramics are brittle material with poor edge strength. Shoulder finish line provides bulk of ceramic at the margin to prevent fracture and also develop proper crown contour to achieve optimal esthetics. In this particular case, on optimum tooth reduction, we found that there was insufficient tooth structure left in relation to 11 (Fig 4) to retain crown and just Incisal 2mm of 21 is needed to be restored to retain the crown. So 21 was restored with light cure composite resin and 11 was restored with custom post and core (Fig 5). The pattern for custom cast post and core was made with self cure acrylic resin (Fig 4) which was later casted. After evaluating fit of cast post and core, it was cemented with glass ionomer cement (Fig 5). The two teeth

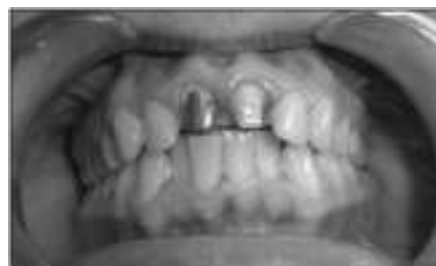
Fig 5 : Cemented Custom Cast Post And Core In 11 And Core Buildup With Composite Resin In 21

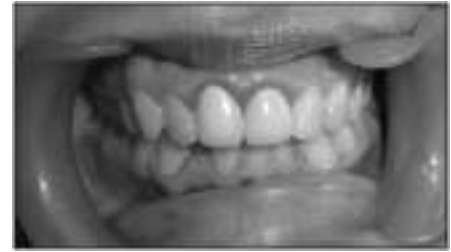
Fig 6 : Labial View- Central Incisors Restored With Pfm Crowns

were finally restored successfully both functionally and esthetically with porcelain fused to metal crowns. (Fig 6). Three year follow up of patient revealed excellent patient satisfaction with well maintained health of periodontium
