Direct Composite Resin Restoration With Supplementary Laboratory Procedure For Esthetically Pleasing And Functionally Efficient Diastema Closure - A Case Report

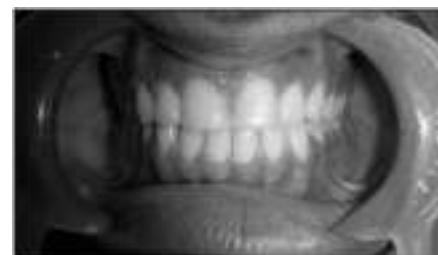
On clinical examination, a discolored composite restoration splinting the two maxillary central incisors in the midline was seen. This restoration had debonded and the patient was using it as a removable prosthesis. (Fig 1) The interdental papilla between the central incisors was flattened and depressed affecting aesthetics of the patient. It was observed that the anterior guidance was present only on the splinted composite

Figure 1. Intraoral view showing stained composite resin restoration splinting maxillary central incisors and depressed interdental papilla

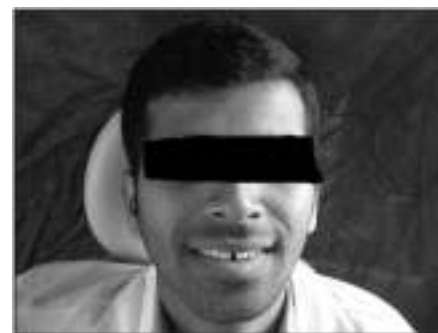
restoration. A diastema of 4mm was noted between 11 and 21, when the debonded composite restoration was removed. (Fig 2).

Figure 2. Extraoral view showing wide diastema between maxillary central incisors affecting smile

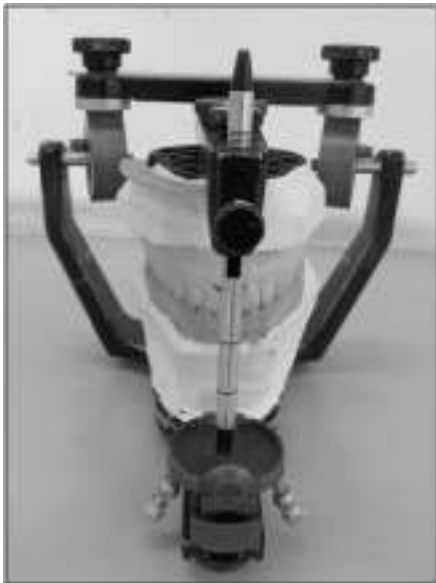
Figure 3. Hanau wide vue semi adjustable articulator used for doing waxup

Maxillary and mandibular diagnostic impressions using irreversible hydrocolloid (Zelgan Plus, Dentsply India) were made and poured with dental stone (Kalstone, Kalabhai India). It was observed that the maxillary central incisors were proportionately smaller compared to the size of right and left lateral incisors and canines. Diagnostic casts were mounted on a semi-adjustable articulator (Hanau Wide Vue II, Whipmix Corp, USA)(Fig 3). There was a scope for increasing the actual width by 1mm on each central incisor which would close the diastema by 2mm. Diagnostic wax-up (Crowax, Renfert GmbH, Germany) was done on 11 and 21 and the width of 11 and 21 was increased by 1mm each by adding inlay wax on mesial sides of both the teeth which closed the diastema by 2mm.(Fig 4). Remaining 2mm of diastema was closed by further adding inlay wax on mesial sides in such a way that the mesial line angles of both 11 and 21 did not further shift towards the midline, which would otherwise affect

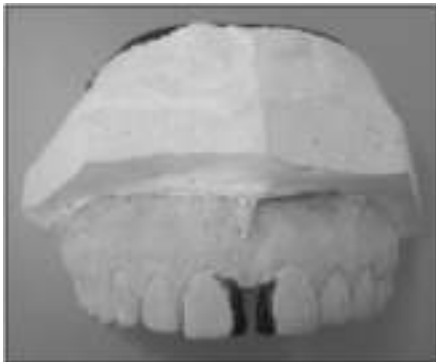
Figure 4. Initial waxup of 1mm width on both central incisors to reduce the diastema by 2mm

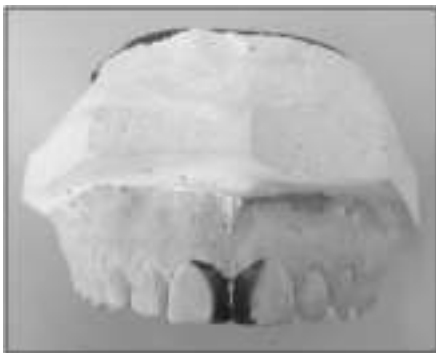
Figure 5. Final waxup to completely close the diastema

aesthetics by changing the proportionality of anterior teeth.(Fig 5). Splinting of the incisors was avoided and emergence profile was maintained to allow space for the interdental papilla to regrow. Protrusive and laterotrusive guidance was assessed such that there was uniform distribution of forces on all the teeth and not on the restoration alone. A putty index (Aquasil, Dentsply, Detrey GmbH, Germany) of the wax-up was used as a guide for the composite build up. Shade selection was done using a (VITA Tooth guide 3D Master) under natural day light. Mesial surface of both the central incisors were roughened using a diamond point. Standard etching and bonding protocol was followed. Incremental layering of direct composite resin restorative material (Venus composites, Heraeus Kulzer, UK) was done on both 11 and 21. Body composite, enamel and translucent shade composites were used in accordance with the enamel gloss and translucency of the adjacent anterior teeth. The index was used throughout the composite build-up procedure. A dental floss was passed between two teeth to confirm the interdental space and embrasure was maintained to allow the inter-dental papilla to grow. Finishing and polishing was done using composite polishing kit (Shofu Inc, Kyoto, Japan) to achieve esthetically pleasing diastema closure (Fig 6 & 7).

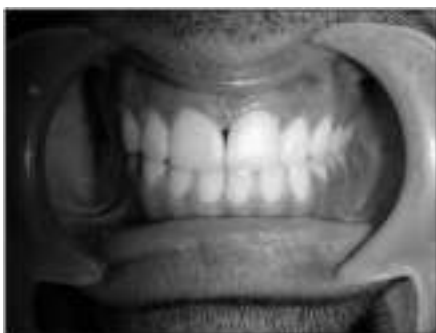
Figure 6. Intraoral view showing esthetically and functionally satisfactory composite resin restoration closing the diastema

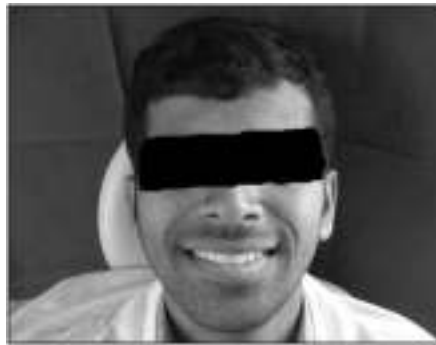
Figure 7. Extraoral view showing esthetically pleasing smile with closed diastema
