## Post Endodontic Treatment Of Discolored Tooth Via Non Vital Bleaching Using Portland Cement In Vivo For First Time As An Intracoronal Barrier - A Case Report

### Abstract

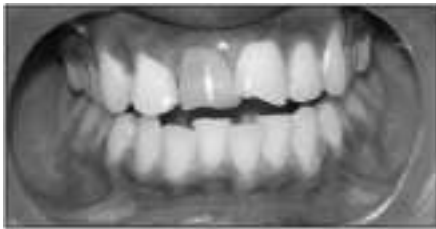
Fig 1 : Pre-operative image of patient's tooth

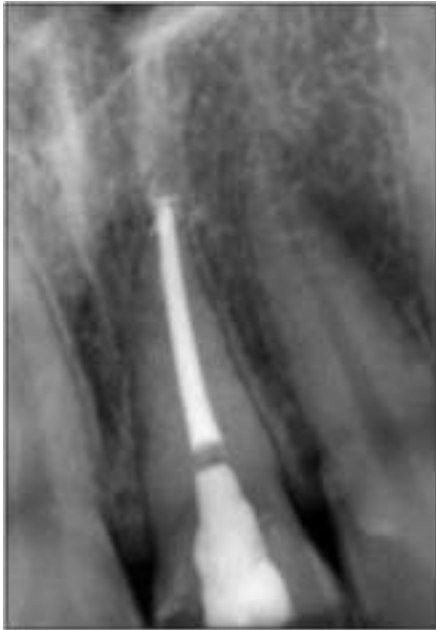
Fig 2 : Pre-operative radiograph of patient's tooth

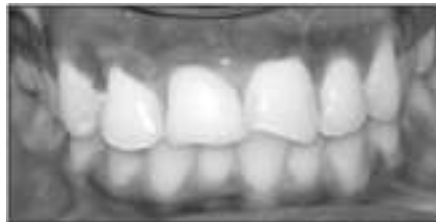
Fig 3 : Radiographic Image after root canal treatment and placement of barrier

alcohol. The pulp chamber was rinsed thoroughly with distilled water. A cervical base of sterilized Portland cement was placed 1mm apical to cemento-enamel junction level. The Portland cement was packed into place with plugger and was allowed to set against moist cotton for a period of 140 minutes. The access cavity was sealed with gutta percha temporary. Following a lapse of 140 minutes the gutta percha temporary was removed. The chamber was etched with 37 % phosphoric acid (Total Etch, Ivoclar Vivadent, Liechtenstein) for 30 seconds and it was washed and dried. A mixture of sodium perborate (in the tetrahydrate form) (Degussa, Hanau, Germany) and 30 % hydrogen peroxide (in the ratio, 1 g of powder: 0.5 ml of liquid) was made and it was placed in the pulp chamber and condensed with a wet cotton pellet<sup>[7]</sup>. A piece of dry cotton was placed over this mixture and the access cavity was sealed with modified zinc oxide eugenol cement (IRM, Dentsply). The patient was recalled after 2 weeks for a review. After 2 weeks, the tooth showed a definitive improvement in the shade, except at the incisal third tooth. So, the internal bleaching procedure was repeated and the patient was recalled after 1 week. The sodium perborate – water mixture was removed from the pulp chamber and the access cavity was sealed with composite resin (Filtek Z350, 3MESPE, MN, USA). Radiographs were taken to serve as a comparison for the subsequent follow up visits. The patient was asked to report after 12 months and 24 months for reviews. The bleached shade was maintained even 24 months after the bleaching and the radiographs showed no evidence of the cervical resorption. Fig 3:

Radiographic Image after root canal treatment and placement of barrier. Fig 4: Post-operative image after 2 weeks follow-up

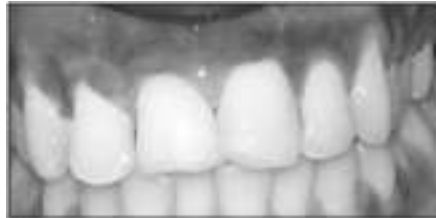
Fig 4 : Post-operative image after 2 weeks follow-up
